This document is the result of an on-site field investigation that categorizes the major systems of the facility and the condition of the equipment inside the building including HVAC, Mechanical Electrical & Plumbing (MEP), Ice Making Systems and Ancillary equipment used for various shows and entertainment purposes at the Hartford Civic Center. This document does not include an engineering evaluation; however, there are several recommendations throughout this document for system alternatives that could lead to a more efficient operation of the facility.

In February 2007, HOK Sport was contracted by the City of Hartford to perform a study of a new civic center to include an update of our previous document and determine changes that have taken place since our last review. The follow-up visit was scheduled and took place with previously involved HOK staff. The following changes, or lack thereof, are noted and presented below. Please note that the format was not changed from the original report so that direct comparisons could be made to the past year.

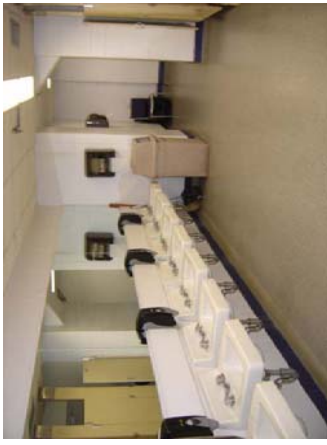
Women's restroom outside Section 114/115 is clean and well maintained:

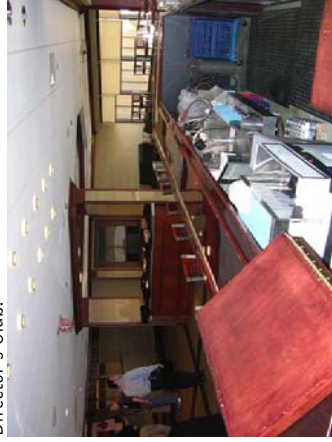
Director's Club:

The Director's Club is clearly the jewel of the facility. Its condition and level of maintenance is equal to or better than that of the suites. One concern for this space, should any upgrading/renovation work be done here, is the lack of ADA compliant wheelchair-accessible seating. Accommodations will need to be made for the minimum number of accessible seating should any work in this area be considered.

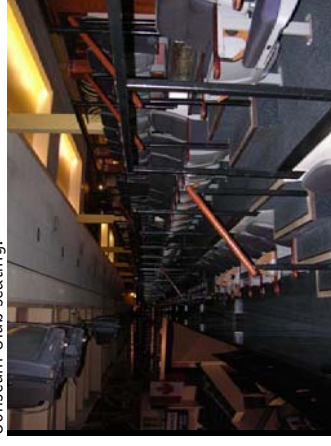
The Coliseum Club appears to be the most utilized premium space in the building. Its condition and level of finish is consistent with the other premium areas. Due to more extensive use, the seating in the front of the club is showing more wear than seats in the suites or Director's Club. The finish on the wooden cup holders and flip-up trays is beginning to deteriorate and the upholstery is showing

signs of wear, though probably not yet to the point of needing to be replaced.

Coliseum Club seating:

One improvement that should be considered is the lowering of the rails in front of the club seating. Current code should allow for a minimum height of 26" in lieu of the current height of approximately 36". This improvement would enhance the site lines and improve the fan experience.

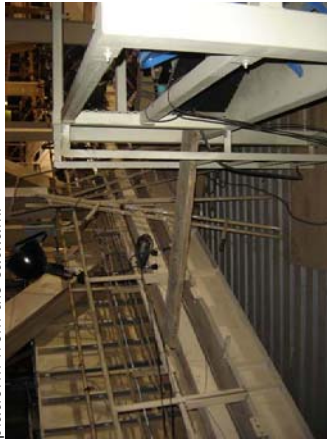
Spotlight platform at SW corner – 2x8 inch board used to access platform from the catwalk:

All of the spotlight platforms we observed were dangerous and none of the spotlights were safetied to the catwalk. The platforms were dirty and there were large amounts of garbage accumulated around and inside many of these platforms. Some platforms had little railing, thus making the potential for falling objects, equipment or operators a threat, especially as some of the operators must traverse areas over the audience to get to the platform. There was also no evidence that spotlight operators are using a safety harness nor was there any evidence that any type of fall protection is being used in these areas. Some of the spotlight platforms had arena chairs for the operators to sit in during shows, though none of the chairs were safetied.

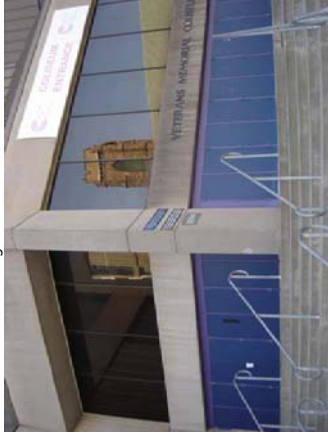
Northwest entrance of the facility where the steps have been re-concreted in the past year. The metal paneling on the backside is still left over from original construction. The facility management has talked about re-doing this back side to make it more appealing:

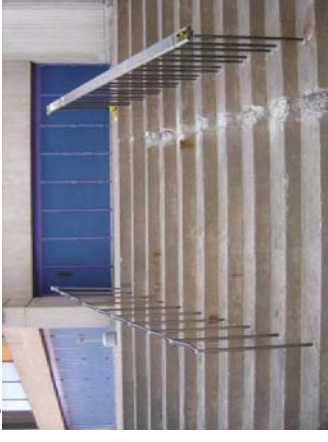
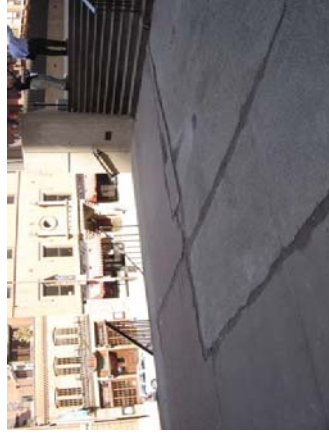
The condition of the exterior is generally well maintained, but there were areas where there was significant delamination of concrete steps and pads, especially at the designated smoking area. The main entrance to the facility along Trumbull Street is accessible and clearly marked by the presence of the LED marquee.

Southwest corner of the building used as a smoking section. There is significant wear and delamination of the concrete steps and pads:

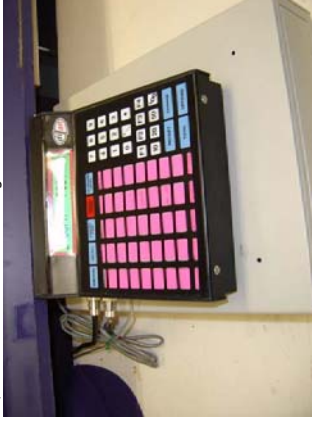
The current Point of Sale system was installed in 1999 and is a Di/An model. The system does not currently accept credit cards and should be upgraded so cards could be accepted at all sales areas, as customers expect that of all retailers, even at smaller fast food chains. Visa and MasterCard studies show that credit card transactions are 15% to 25% greater than cash transactions, so adding credit card capabilities can increase sales. In observing the long lines at the Center's ATM machines, it is obvious that customers do not carry enough cash, and making it inconvenient to use their credit and debit cards only impedes sales and lessens the fan experience.

Di/An POS terminal in Brigham's Ice Crème stand:

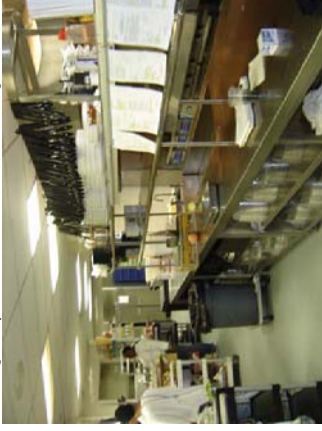
Kitchen on suite level has enough space to accommodate large scale cooking for premium areas and catering activities:

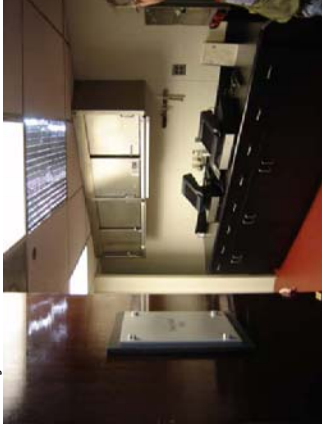
Pantry on the suite level used to service the suites is in good condition:

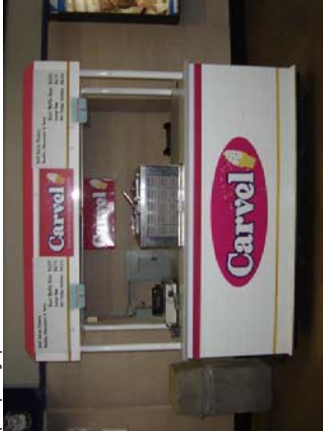
Ice crème portable section 113/114 is in good condition and properly placed on the concourse:

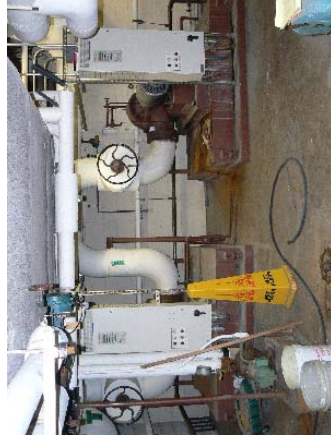
The central plant room and its equipment have been well maintained and we noticed that several pieces of equipment such as small pumps and regulating valves have been replaced. However, as the picture below illustrates, the equipment and its support system is old and showing signs of deterioration such as numerous leaks, evidenced by the buckets catching water leaks from overhead pipes and previous leaks around the chilled water pump pads.

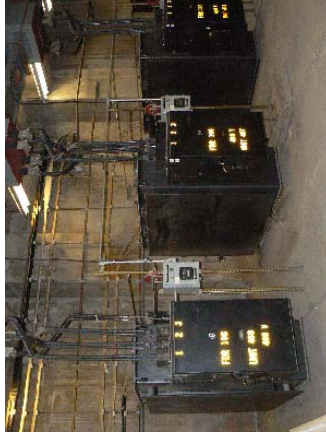
Primary Electrical service for the facility is provided by three separate pad mounted utility transformers located inside the facility. These transformers are owned and operated by the local utility company. The transformers are original equipment and seem to be operating properly and are rated for 3,000 amps each @ 480 Volts. There was no evidence of PCB testing and the operations staff did not know if a load test had ever been performed.

Due to the age of these transformers, it is recommended that proper documentation be obtained from the utility company to determine if the equipment meets local and federal standards. It is also recommended that a written contingency plan be instituted to insure a replacement transformer can be obtained in a timely manner should a failure be encountered.

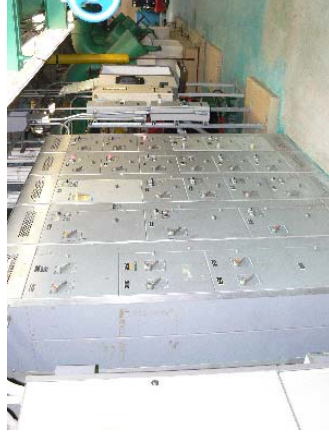
Should part of a low voltage or high voltage electrical box be partially destroyed due to a failure, the entire panel box or feeder box will have to be replaced. The low amperage electrical panels should not pose much of a problem; however, the high amperage distribution and feeder panels could cause the facility to be shut down for several days or possibly weeks depending on severity and location of the problem.

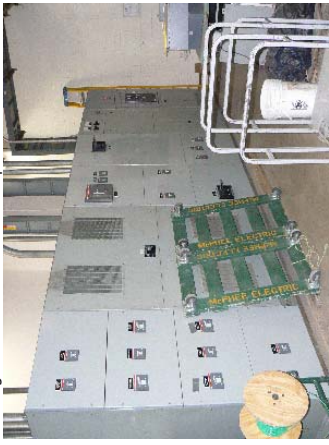
Note the storage of event equipment and the dust / grease residue coming out of the vents in this panel:

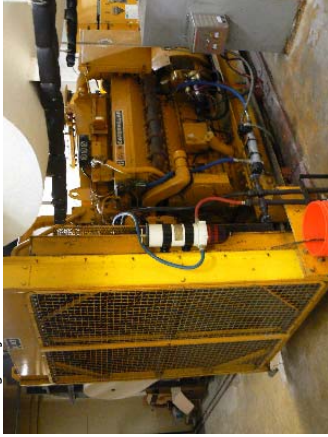
Emergency Generator:

Emergency Electrical Power
Caterpillar Engine 500 KVA Generator
The emergency generator is original equipment and seems to be in good working order. The maintenance staff exercises the unit once a week as evidenced in the logs placed near the generator. According to the staff, the generator runs well and has no apparent problems.

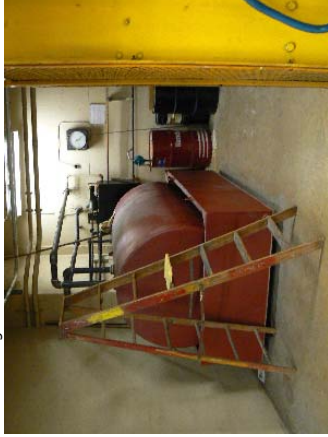
Fuel Storage Tank:

Adjacent to the generator system is a 400-gallon diesel fuel tank to feed the generator fuel. According to the staff, a larger tank located outside the generator room was recently removed due to space constraints.

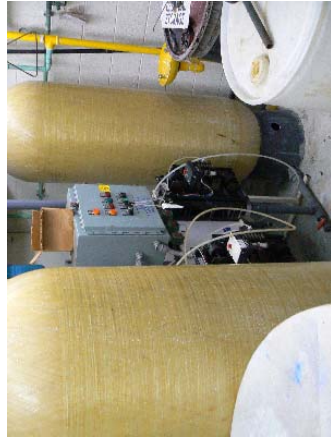
the system is working properly but did not test any of the ice making water. The covers on the automatic mixers were missing and the internal piping was exposed. Both tanks of acid and caustic soda are stored in front of the unit and could cause problems should there be a leak and maintenance personnel need to make emergency repairs quickly.

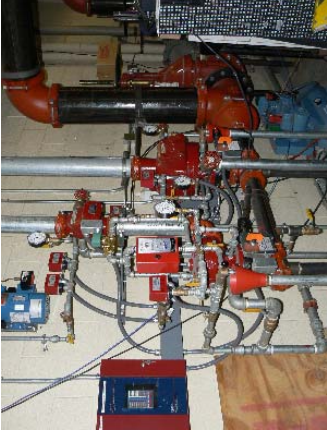
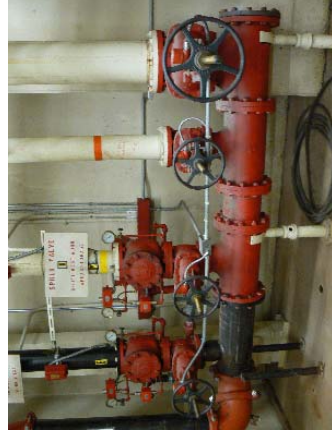
All of the fire protection systems seemed to be maintained to a high standard and the dry system was observed to be almost new. There were four separate locations we observed, though none of the systems we observed had any type of inspection tags indicating testing dates or any type of flow certification associated with any of the units. There were also numerous pieces of equipment stored in some of these areas leaving little access to the units or controllers in case of an emergency. According to the staff, plans were in place to start a bid process to have this work completed by a licensed testing company. The main water backflow-preventer had been recently repaired and has a current certification tag attached.

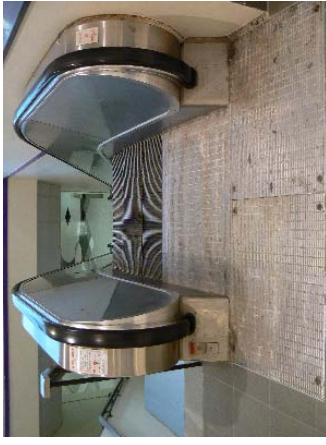
The escalators are showing signs of deterioration due to usage and age, especially the escalators near the entrance to the main office. They were observed to be loose and

making noises near the top of the landings. These noises may be an indicator of loose or worn out roller bearings and guides in the steps and the support railings.

A complete mechanical survey conducted by an independent contractor is advised due to the age & condition of these systems. It would not be unusual for complete replacement in the near future due to the age. Other problems can arise when new components are incorporated with older components causing conflicts with electronic and mechanical parts and systems resulting in a shut down.

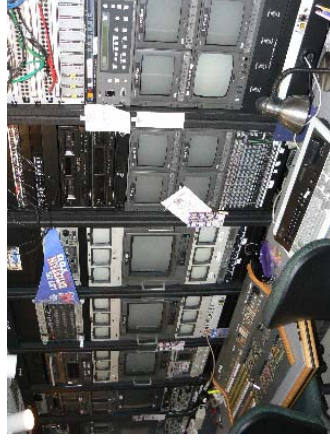
Mounted on the ceiling of the roof structure is the center hung scoreboard / video and its winch system. The scoreboard is a four-sided system manufactured by Daktronics and is operated by a control system in the lobby. The control system for the video production is also housed in the lobby and can accommodate almost any type of video production. There are also patch panels and feeders for video feeds from production trucks outside the facility.

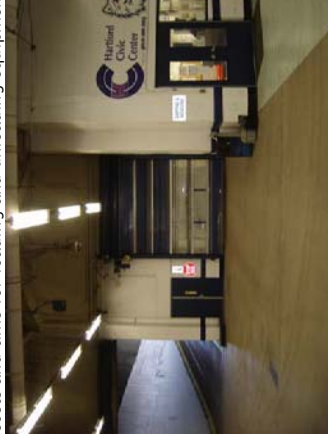
Roll up door from loading dock to marshalling area. Production trucks must be loaded and unloaded with ramps, which increases labor costs and time for loading and unloading equipment:

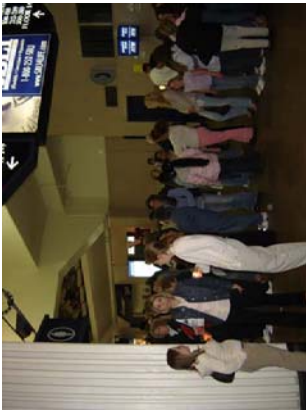
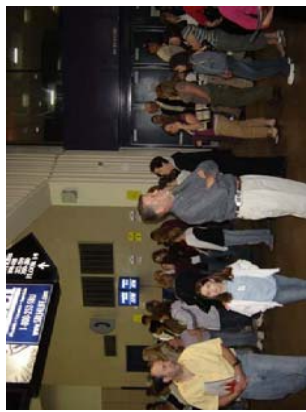
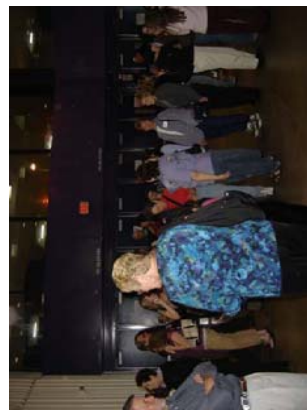
Long lines at the restrooms and concession stands were observed throughout the night at the Billy Joel concert. The one public concourse is not sufficient to accommodate pedestrian flow of a crowd of 15,000. Public restrooms, whose numbers were designed to accommodate 10,000, are woefully deficient in servicing a crowd of 15,000. A renovation of the facility to meet current code and design standards for public assembly facilities for public restrooms may be prohibitive. The renovation would consequently require upgrades to all facility's spaces to ADA compliance.

One line for a Women's restroom. This was typical of most restrooms at the HCC:
